Manhole Inspection Summary

Manhole # S29U1_004MH

Location Address: **601 W. Patapsco Ave.**

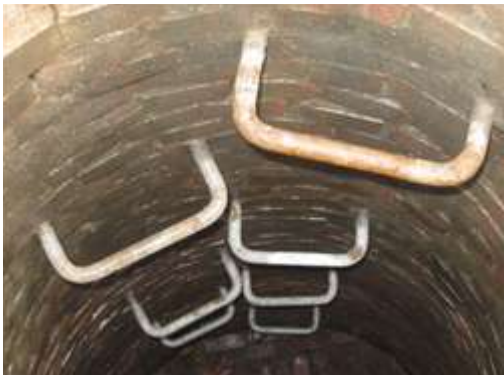
Steps Count: **7** Missing: **0** ☐ Corroded

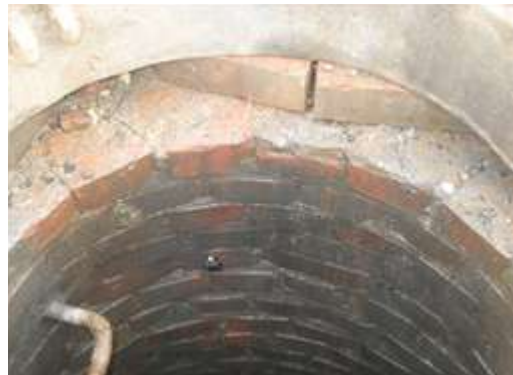
Defect 1

Frame Offset: **2.5** (in.) Condition: ☒ Sound ☐ Cracked ☐ Leaks

Condition: ☐ Sound ☐ Cracked ☐ Root Intrusion ☒ **Loose Brick** ☐ Deteriorated

Infiltration: ☐ None ☒ **Joint** ☐ Cracks ☐ Mortar ☐ Roots ☐ Wall

Frame offset/loose bricks

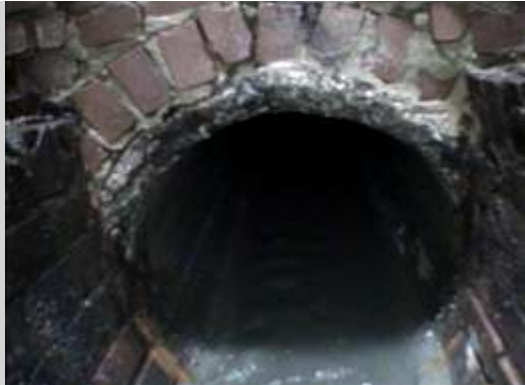
12 O'Clock Outflow

21 in. Circular Gravity Sewer
Pipe Out @ 12 O'Clock

Pipe Height: **22.8** (in.) Rod and Bar (Angled)
Pipe Material: **Concrete** ☐ Pipe Lined
Invert Depth: **13.70** (ft.) Flow Characteristics: **Fast**
Deposits: ☒ None ☐ Mud ☐ Sludge ☐ Debris ☐ Grease
Silt Depth: (in.) Deposits Extent:
Infiltration: **None** Pipe Seal Cond: **Sound**

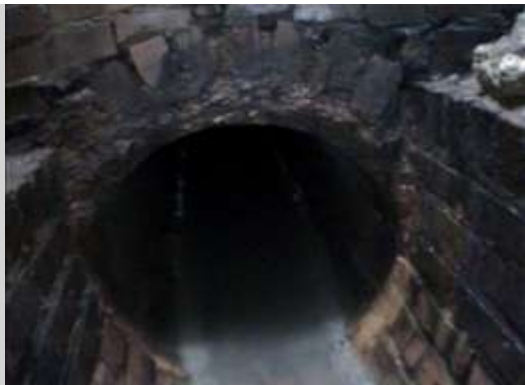
6 O'Clock Inflow

21 in. Circular Gravity Sewer
Pipe In @ 6 O'Clock

Pipe Height: **21.6** (in.) Rod and Bar (Angled)
Pipe Material: **Concrete** ☐ Pipe Lined
Invert Depth: **13.50** (ft.) Flow Characteristics: **Fast**
Deposits: ☒ None ☐ Mud ☐ Sludge ☐ Debris ☐ Grease
Silt Depth: (in.) Deposits Extent:
Infiltration: **None** Pipe Seal Cond: **Sound**
